Manhole Inspection Summary

Manhole # S11QQ1008MH

Insp Date: **5/1/07 12:11 PM**

Location Address: **4919 QUEENSBERRY AVE**

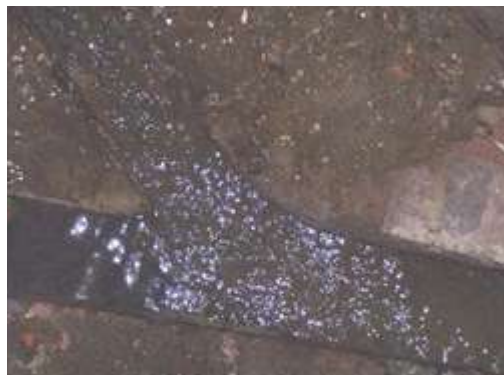
Defect 2

Condition: ☐ Sound ☐ Cracked ☐ Root Intrusion ☐ Deteriorated ☐ Leaks ☒ **Debris**

DEBRIS

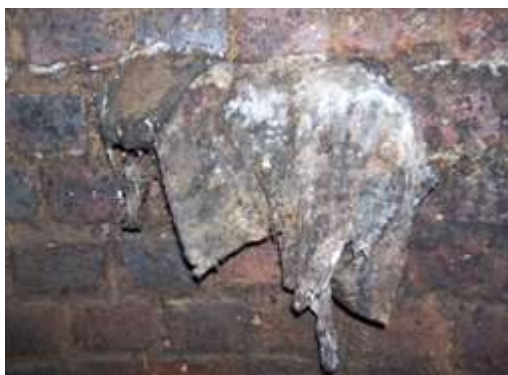
Defect 1

☒ **Evidence Of Surcharge** Depth: **5** (ft.) ☐ Active Surcharge Present

EVIDENCE OF SURCHARGE 5 FT

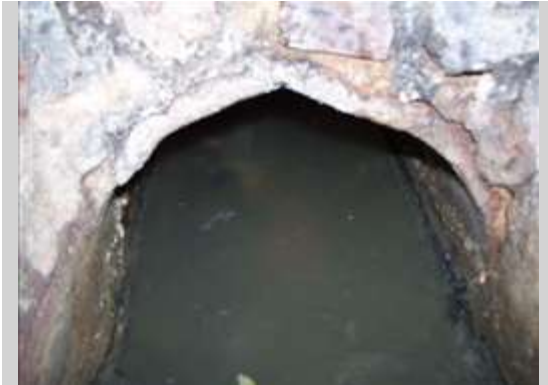
12 O'Clock Outflow

8 in. Circular Gravity Sewer
Pipe Out @ 12 O'Clock

Pipe Height: (in.) Direct
Pipe Material: **Clay** ☐ Pipe Lined
Invert Depth: **10.45** (ft.) Flow Characteristics: **Slow**
Deposits: ☒ None ☐ Mud ☐ Sludge ☐ Debris ☐ Grease
Silt Depth: (in.) Deposits Extent:
Infiltration: **None** Pipe Seal Cond: **Cracked**

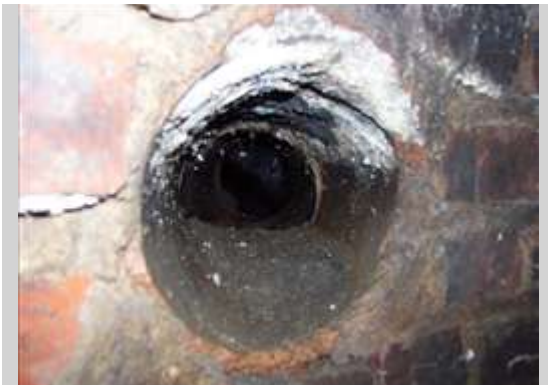
1 O'Clock Inflow

6 in. Circular Gravity Sewer
Pipe In @ 1 O'Clock

Pipe Height: (in.) Direct
Pipe Material: **Clay** ☐ Pipe Lined
Invert Depth: **6.95** (ft.) Flow Characteristics: **None**
Deposits: ☒ None ☐ Mud ☐ Sludge ☐ Debris ☐ Grease
Silt Depth: **0.5** (in.) Deposits Extent: **Light**
Infiltration: **None** Pipe Seal Cond: **Sound**

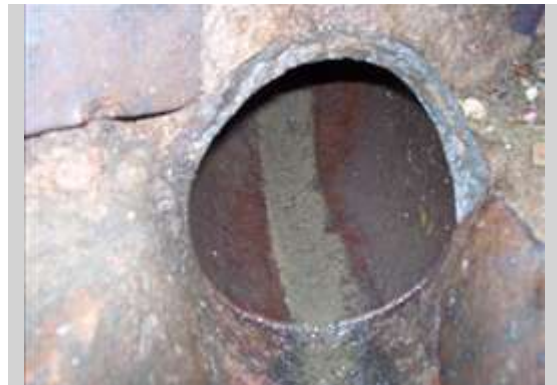
Drop In @ 1 O'Clock

Drop: **Outside Direct**
Angled: Reading: (ft.)
Inv Depth: **9.85** (ft.)
Drop Condition: **Open**

Connects To: **House connection / Service line**

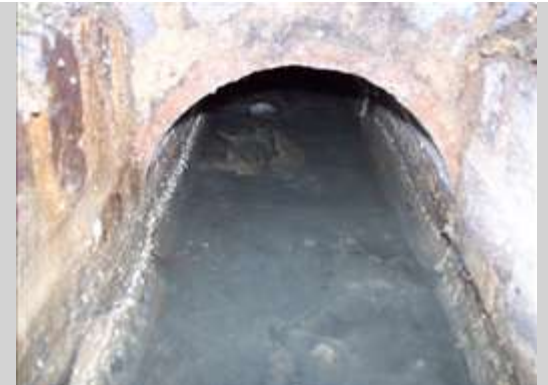
6 O'Clock Inflow

10 in. Circular Gravity Sewer

Pipe In @ 6 O'Clock

Infiltration: **None** Pipe Seal Cond: **Sound**

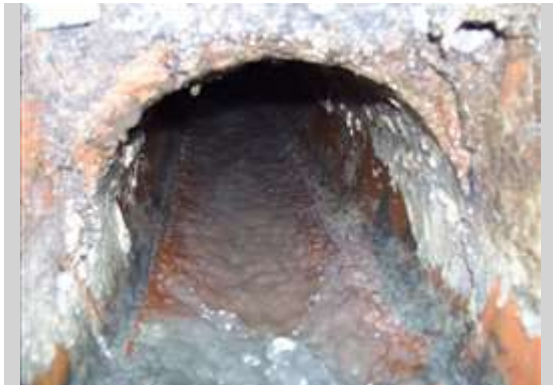
7 O'Clock Inflow

8 in. Circular Gravity Sewer

Pipe In @ 7 O'Clock

Infiltration: **None** Pipe Seal Cond: **Sound**
